Case Study – Robinson Pool

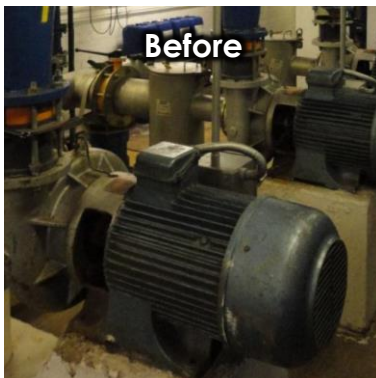
Before

The existing installation of three 40-year-old Worthington Simpson pumps, using inefficient 9.3kW motors and installed with non-DIN standard cast-iron pipework, were leaking excessively. The build-up of scale on the inside of the pipework added to the inefficiency, as well as creating water quality problems.

Both the pumps and the pipework needed replacing. Having identified the specific issues and challenges, deckpro pumps specified inverter-driven Modus pumps connected to a bespoke-made control panel, to adjust the speed of the pumps automatically when the demand reduced (for example, when there were no swimmers in the pool).

The new pipework was pre-fabricated, brought to site ready-to-install and craned into place, ensuring that the pumps and pipework could be replaced in one night so that the pool could remain fully operational during normal opening times.

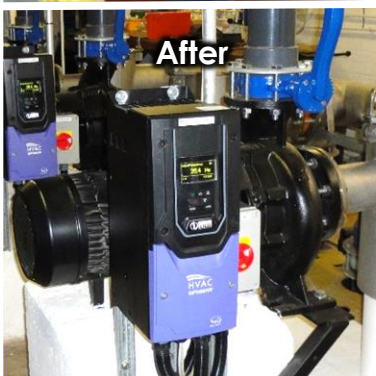
After

The result is a highly-efficient, low-maintenance pumping operation. The pumps use a combined total of about 82% less energy than the before, the quality of the pool water is improved, and this has been achieved with no inconvenience to customers or staff.
